OACIS

Open Architecture Control Integrated System

Maintenance Instruction

Version 02.04

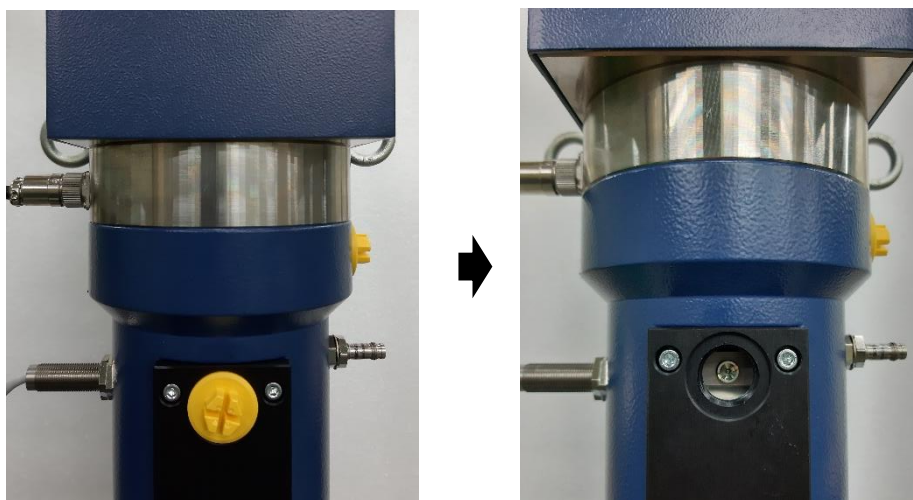
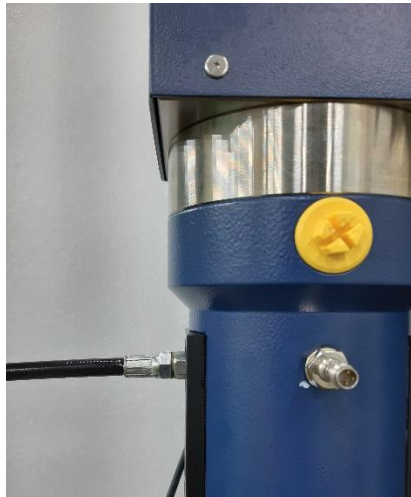
**Lubrication Port #1**

- It is generally necessary to replenish grease on a regular basis.
- Lubrication Management
 - Grease Type: NLGI(National Lubricating Grease Institute) 2
 - Injection Volume: Max 1cc per month

- Lack of lubrication will shorten the life of the system, increase tolerance and etc.
- Contaminated lubrication is as bad as no lubrication.
- It is strongly recommended to cycle the system regularly even there is no production to keep lubrication in the system.
